## Heritage Stone 3. Degradation Patterns of Stone Used in Historic Buildings in Brazil\*

A.G. Costa

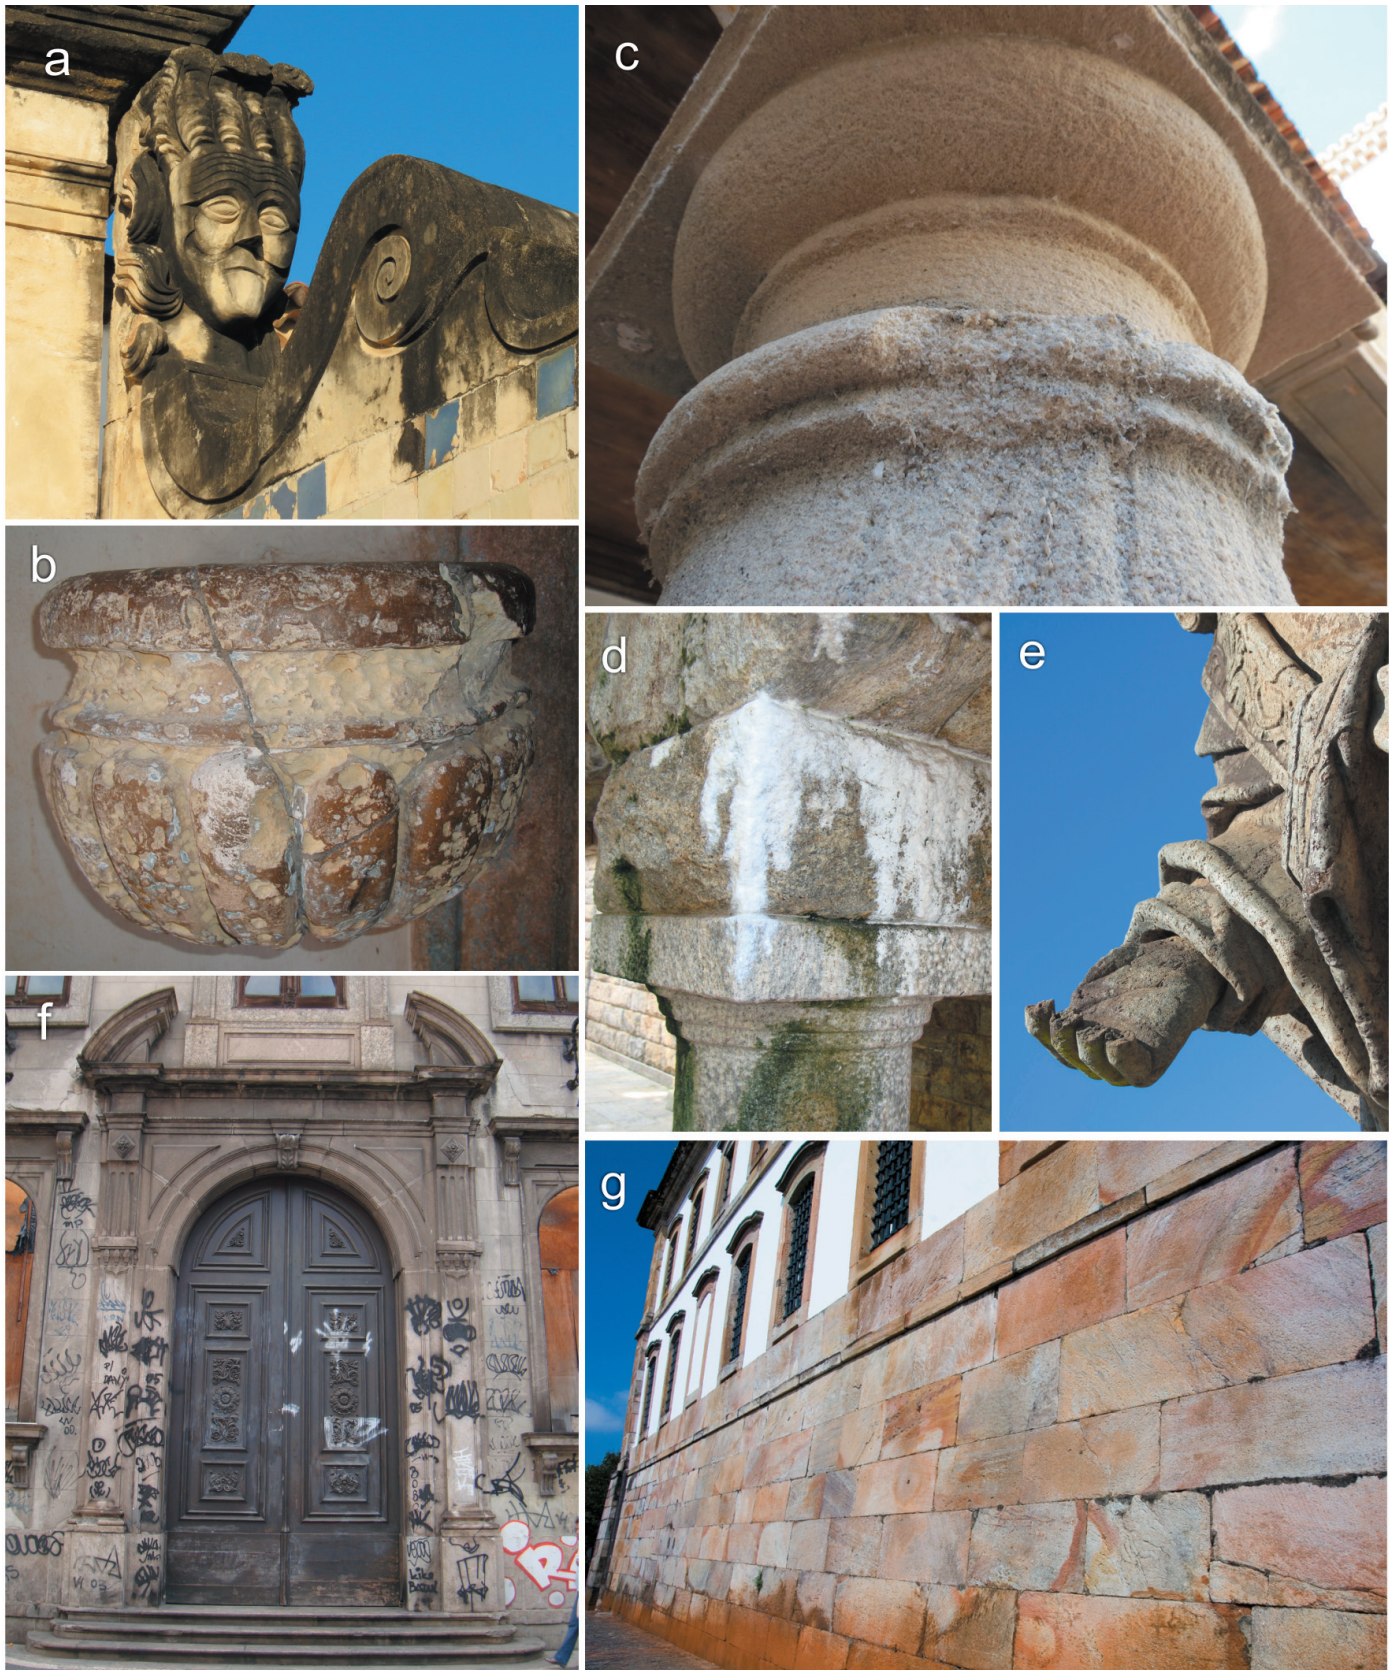
**Figure 3.** Examples of damage that attest to some of the processes responsible for decay or alteration of the stone in some historic monuments built in Brazil. a) Biological colonization and black crust on limestone in the São Francisco's Convent in João Pessoa (state of Paraíba); b) crack and alveolization of limestone in the Church of São Pedro dos Clérigos in Recife (Pernambuco); c) disintegration of calcarenite in São Francisco's Convent in João Pessoa (state of Paraíba); d) encrustation associated with gneiss in the Palacete Laje in Rio de Janeiro (state of Rio de Janeiro); e) missing part on one of the prophet statues at the Bom Jesus Sanctuary of Congonhas (state of Minas Gerais); f) graffiti on the Church of Santíssimo Sacramento in Rio de Janeiro (state of Rio de Janeiro); g) patina formed on quartzite in the old Chamber and Prison House in Ouro Preto (state of Minas Gerais).

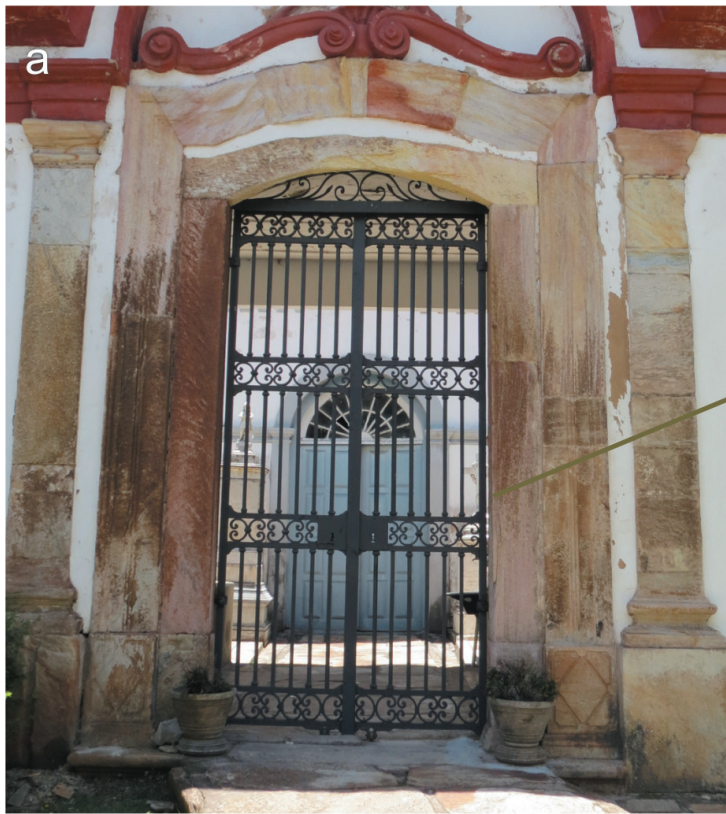
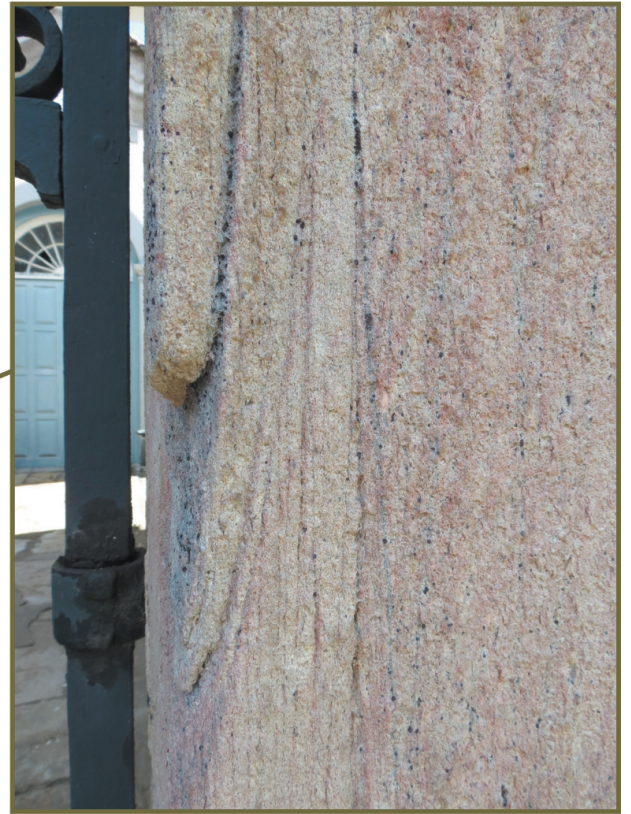
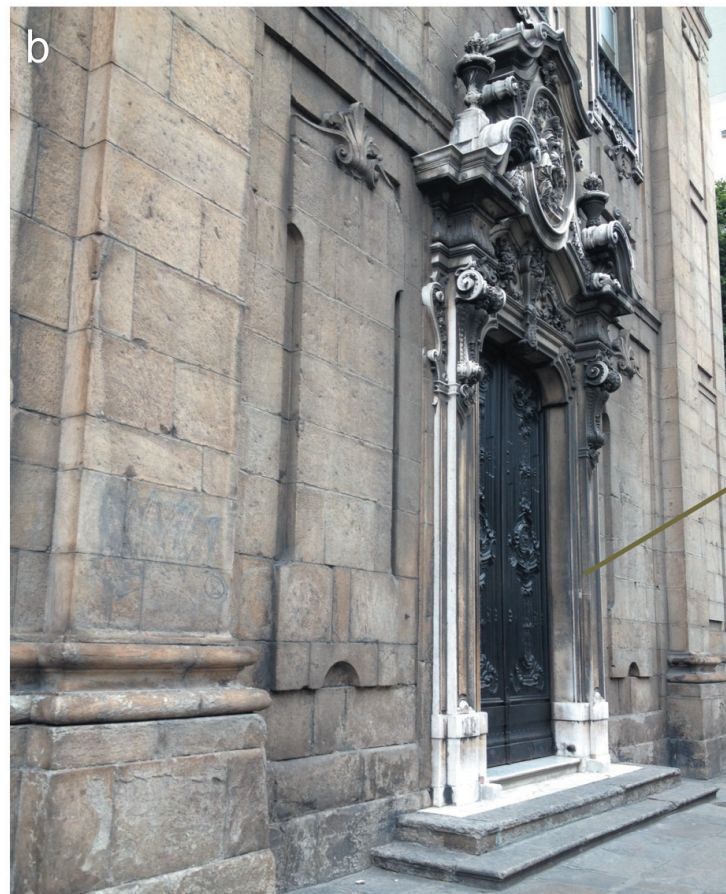
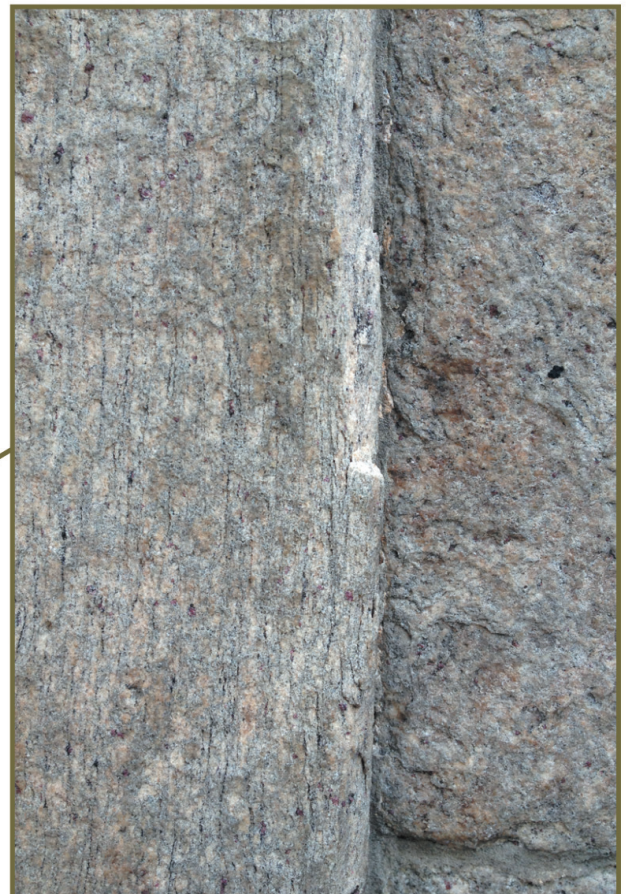
Some types of degradation were directly influenced by the textures and structures present in the stone employed. The presence or absence of a foliation, as well as variations in mineral content, are important factors. For example, where foliated rocks such as schist have been used, decay processes occur faster. Depending on the content of mica, planar structures may develop, and detachments ranging from delamination to exfoliation parallel to the stone structure demonstrate the strong influence of the rock's anisotropy.

**Figure 4.** Detachment processes observed in parallel-cut blocks in which surface exfoliation is parallel to vertical foliation planes (schistosity) in a) a sericite-quartzite application in Ouro Preto, Minas Gerais, and b) a garnet gneiss application in the city of Rio de Janeiro.

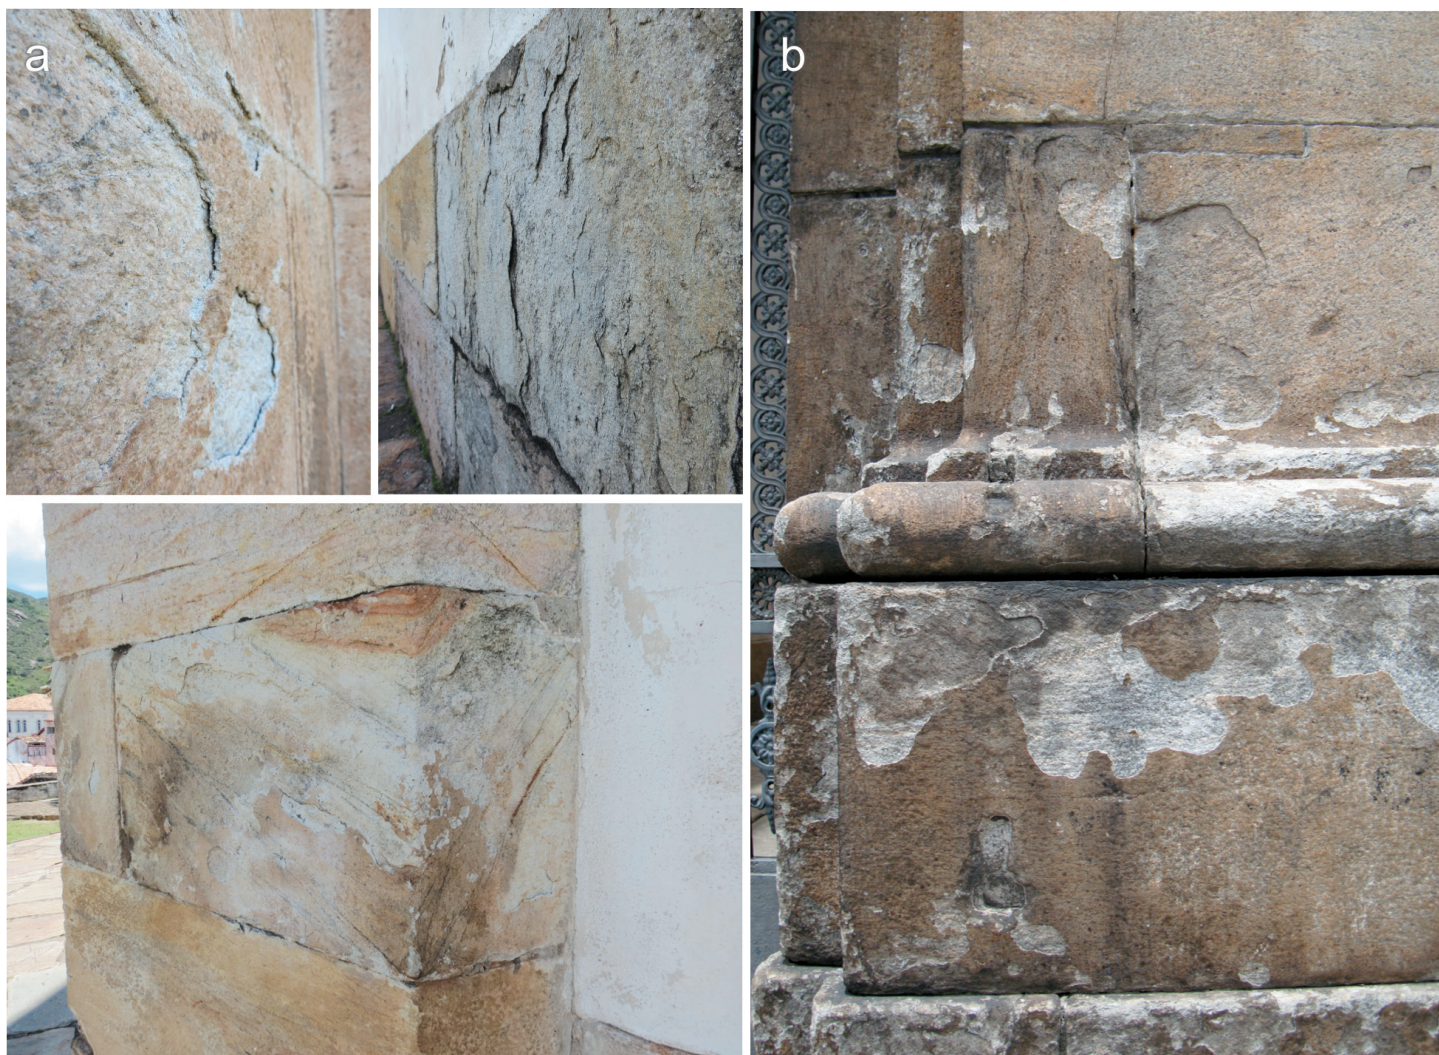
Susceptibility is also associated with the type of rock-cutting method employed: blocks have been cut indiscriminately both parallel and perpendicular to rock foliation planes with concern for matching the type of cut with the requirements in each of those applications. Thus, in the parallel-cut blocks, where foliation planes lie vertically (Fig. 4), decay occurs rapidly as a result of surface delamination or exfoliation and separation of one or more layers. In some cases of detachment, separation involves submillimetric to centimetric elements such as flakes or scales parallel to the stone surface, although not following the stone structure. In such cases, as is observed at the external and flat wedges of the Capela de Nossa Senhora do Carmo (Chapel of Our Lady of Carmo) in Ouro Preto (Minas Gerais state), the process was identified as spalling (Fig. 5).

**Figure 5.** Example of stone detachment as flakes or scales (spalling). In this case, detachment is parallel to the block surface but not to the rock structure, as observed in a) the external and flat wedges of quartzite at the Carmelite Chapelin, Ouro Preto, Minas Gerais, and b) gneiss at the Carmelite Church in Rio de Janeiro.

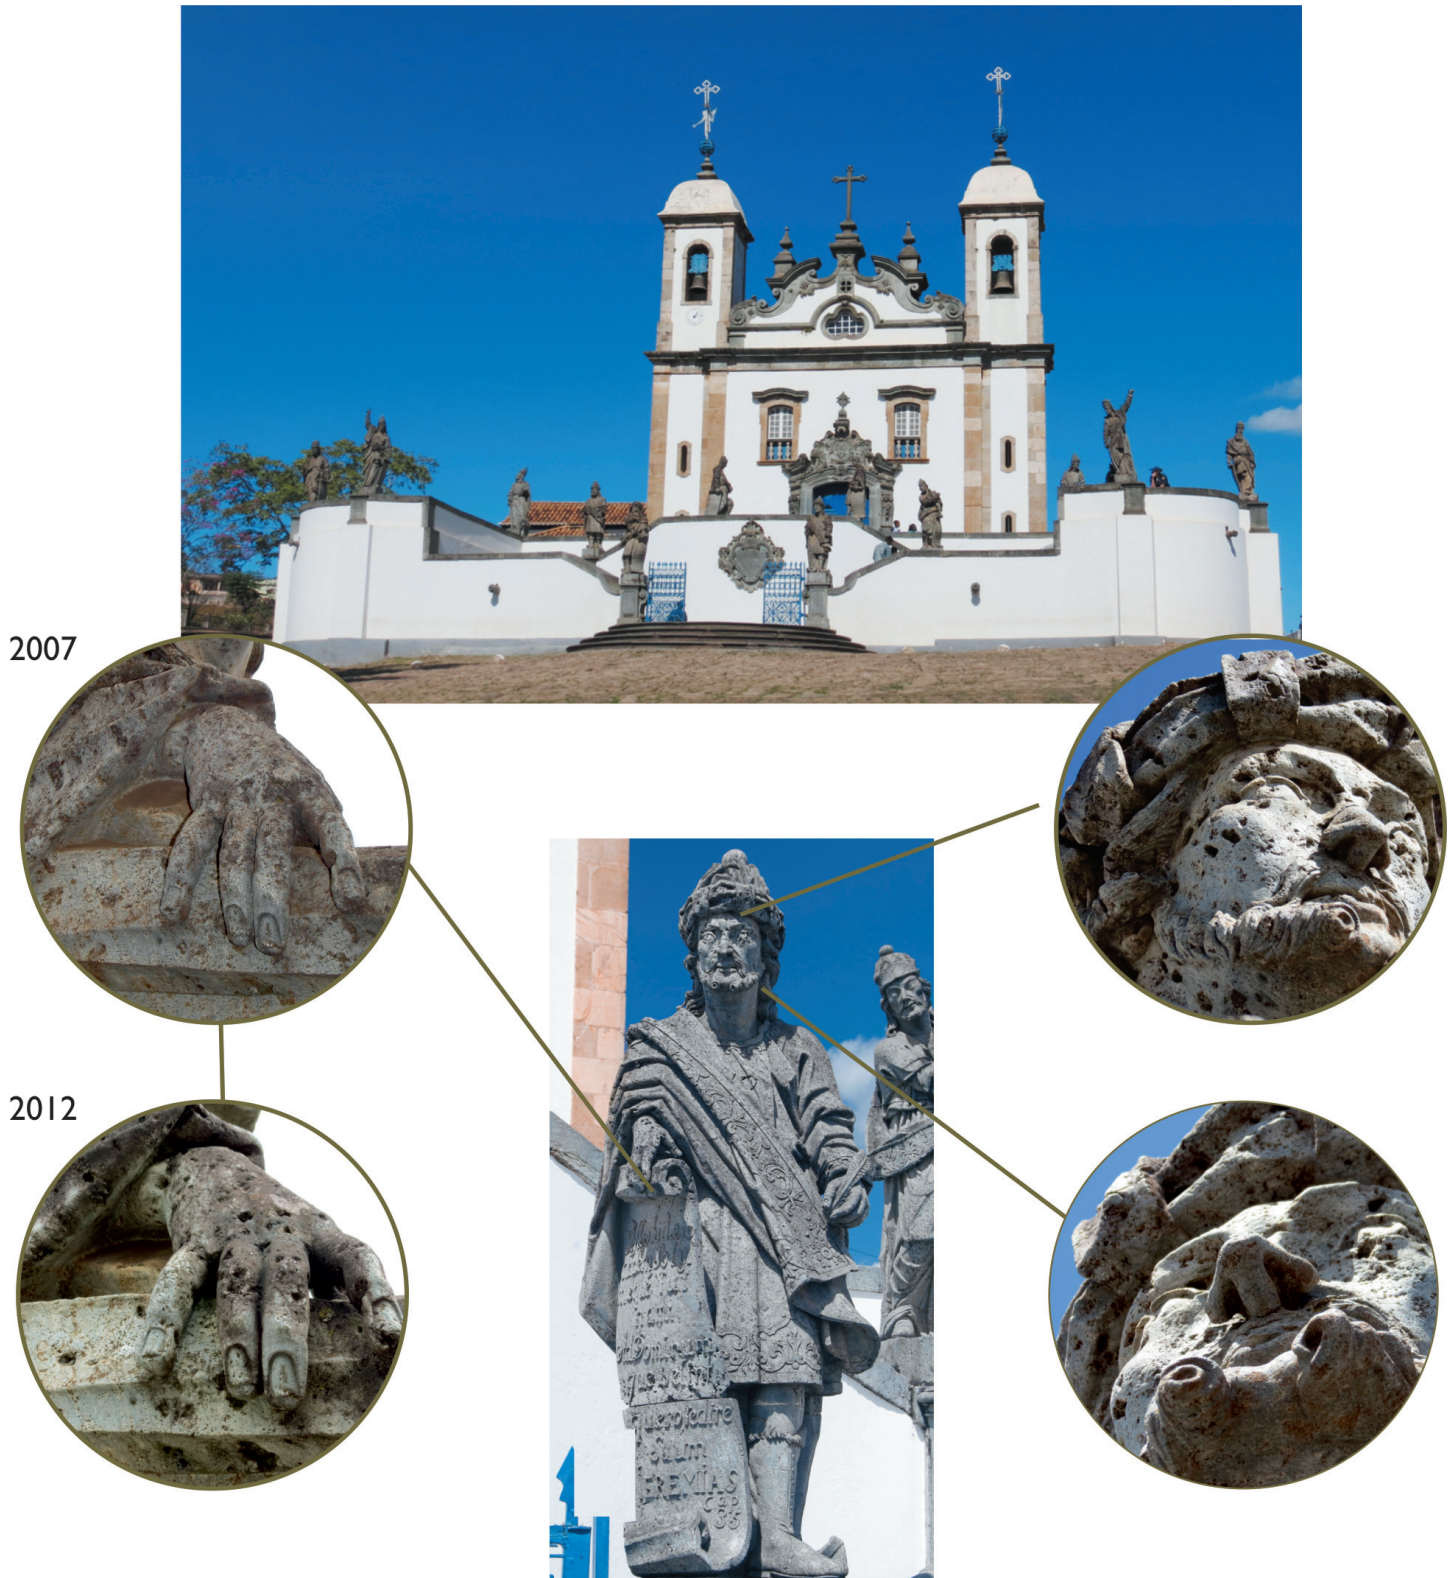
The presence of sedimentary structures inherited in metamorphic rocks may influence processes of degradation, such as in some of the quartzite used. Banding by compositional variation, or cross-bedding, occurring alone or in combinations, can lead to different degrees of degradation, and the effect of these structures may be enhanced by differential erosion. Some of the processes observed were strongly influenced by the mineralogical composition of the rocks employed, as in the case of steatite. Although prone to scratching because of the softness of its main mineralogical component, steatites contain a significant number of different minerals, and each mineral phase has its own coefficient of thermal expansion, contributing to the appearance of fissures and cracks. Broadly speaking, however, the main types of damage observed in steatite applications involve the appearance of cavities, because minerals formed from local enrichment of iron oxide or sulfide (pyrite) are easily removed by alteration/weathering. The common presence of carbonate crystals, usually dolomite, also contributes to the formation of such cavities through dissolution, accelerated in part by acid rain. An instructive example of the process of cavity or alveoli formation in steatite is seen in the statues of the prophets installed in the churchyard of the Santuário do Bom Jesus (Good Jesus Sanctuary) in Congonhas, Minas Gerais. Visual examination over the past 15 years has showed that, within the last 7 years, the process has accelerated. Throughout this period, it was noted that stains

gave rise to cavities, some of which were 0.5 to 1.0 cm deep (Fig. 6).

**Figure 6.** Deterioration of steatite (soapstone) works produced in the late 18<sup>th</sup> century, such as those shown here in Congonhas Sanctuary, mainly caused by weak rock resistance, and by biological and anthropological factors leading to cavity or alveoli formation.

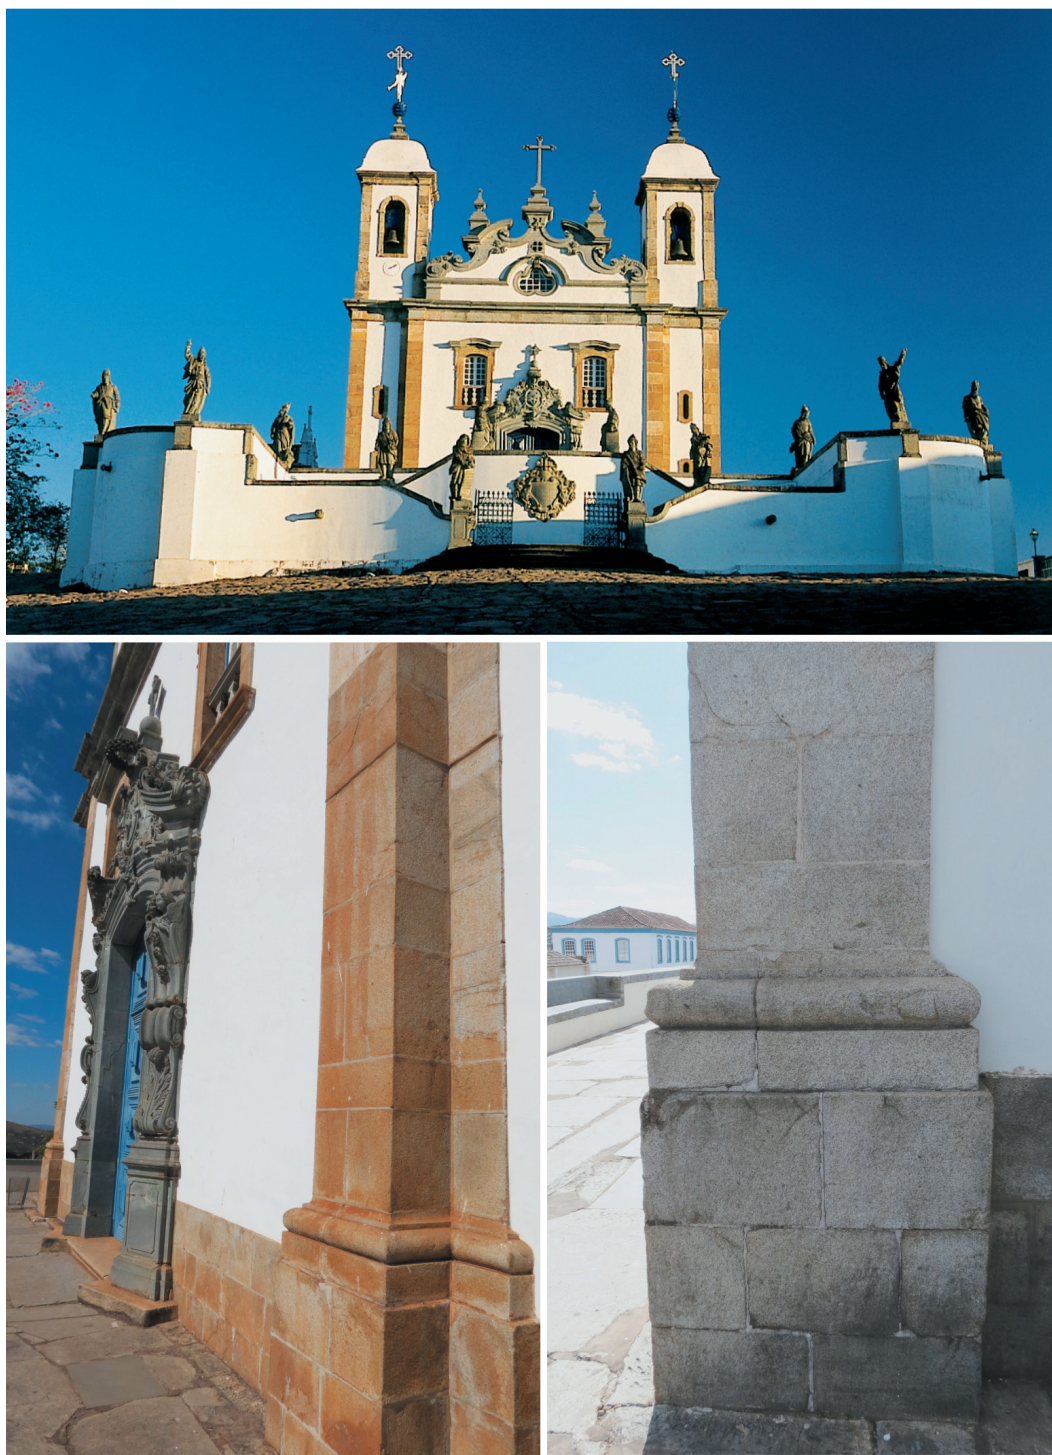
**Figure 7.** Example of patina formation (oxidation), deposition of particles, and biological colonization on the surface of granite blocks with whitish-grey original colour, on the frontispiece of the Congonhas Sanctuary of Bom Jesus church. The current brownish colour (patina) results from the position of these (outer) blocks facing the action of wind currents and variations in moisture content. In areas unaffected by such currents, the granite retains its original whitish-grey colour, although it is susceptible to intense biological colonization.

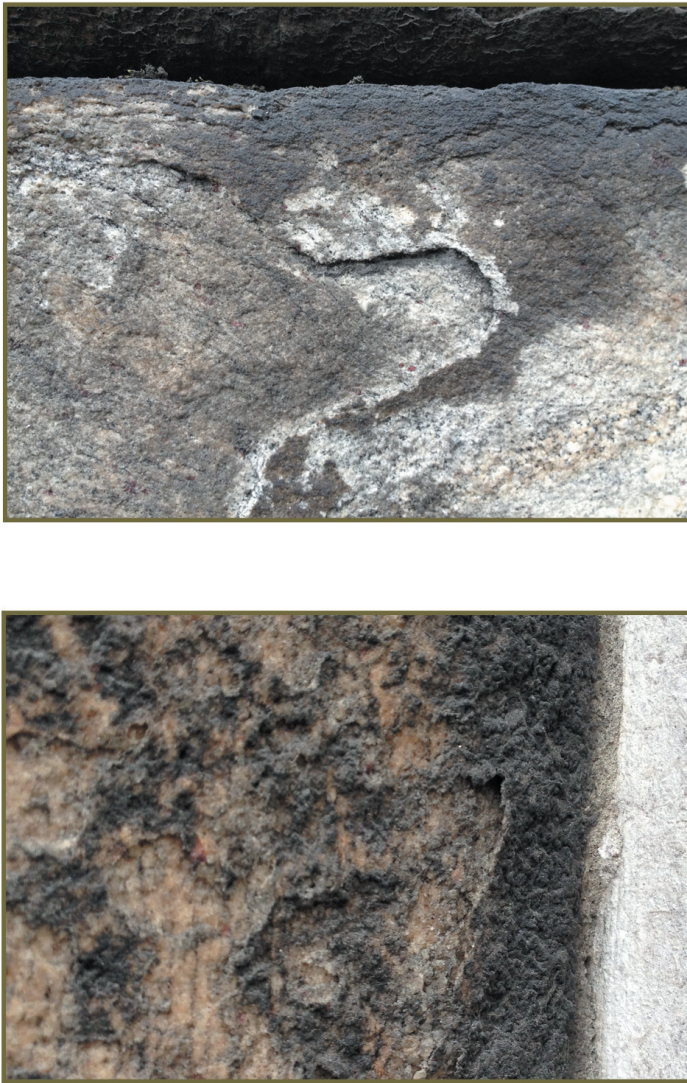
Finally, in historic sites located in urban centres heavily affected by air pollution, such as in Rio de Janeiro and São Paulo, external surfaces are commonly covered by grey to black deposits of varying consistencies and degrees of adhesion to the substrate. In some cases, these deposits occur in areas protected from the rain; in others they are in areas exposed to open air and may be directly affected by rain water. The deposits differ in thickness and shape, ranging from inconsistent layers of pulverulent (powdery) material on horizontal surfaces, to surface deposits well adhered to the substrates. As black crusts, they are frequently associated with serious problems of stone degradation, manifested as exfoliation or blistering (Fig. 8).

**Figure 8.** Degradation observed in historical buildings and identified as black crust. Formed by the accumulation of particles deposited on the flat surface of fine-grained garnet gneiss, the crust is associated with a blistering process on the façade of the Carmelite church, Rio de Janeiro.
