## Heritage Stone 1. Repair and Maintenance of Natural Stone in Historical Structures: The Potential Role of the IUGS Global Heritage Stone Initiative\*

Dolores Pereira<sup>1</sup> and Brian R. Marker<sup>2</sup>

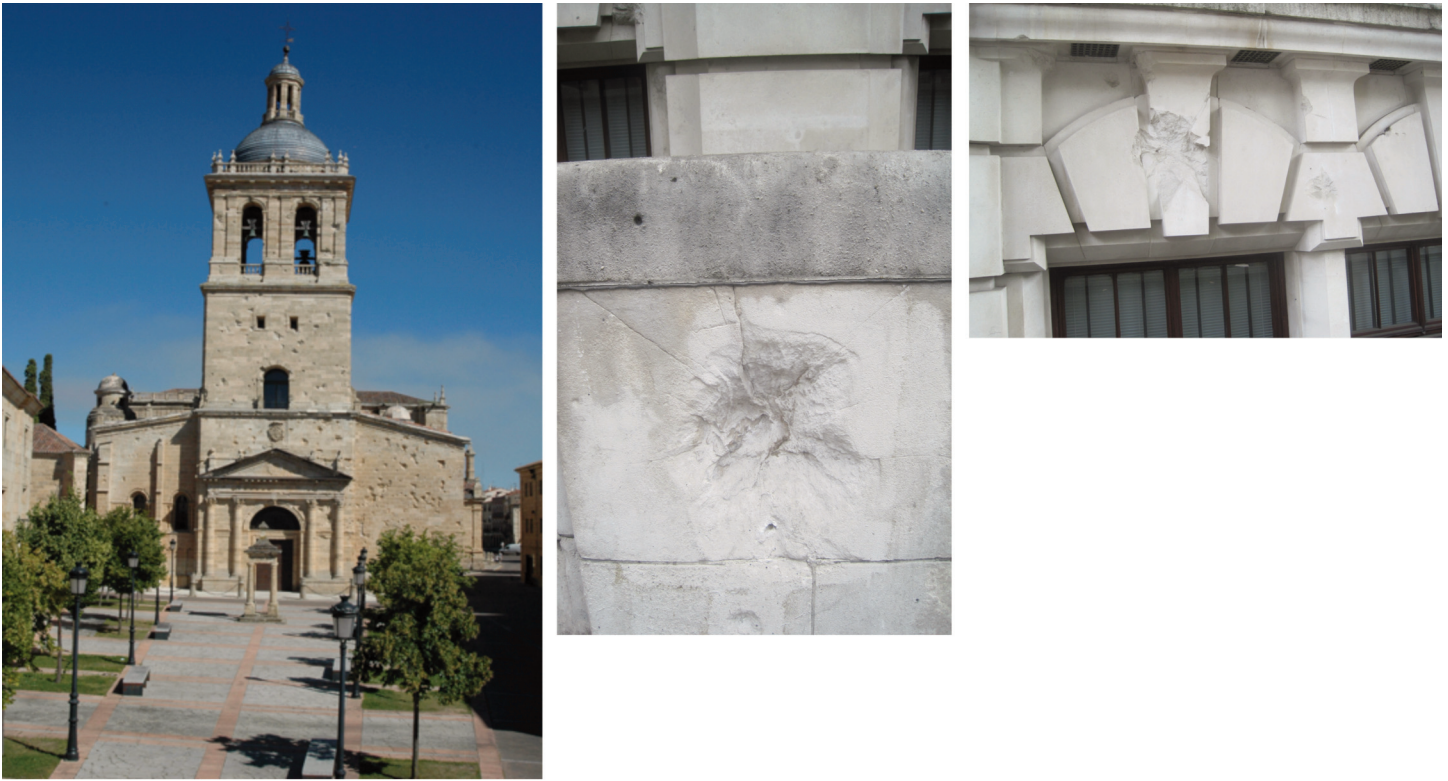
**Figure 1.** Examples of war damage: a) Cathedral in Ciudad Rodrigo (Salamanca, Spain) showing cannon ball impacts from the siege during the Peninsular War between French and Anglo-Portuguese and Spanish forces in the early 19<sup>th</sup> century. b) and c) parts of the façade of the Victoria and Albert Museum in London showing damage to the Portland Stone from casing fragments when bombs were dropped nearby. The damage was deliberately left unaltered when the façade was cleaned and repaired in 1985.

have endangered historical areas and sites for centuries, causing damage or, in some cases, complete destruction (Fig. 1). Recent and current political instability in some places, including some UNESCO World Heritage sites, is a matter for continuing concern but can only be solved by conflict resolution.

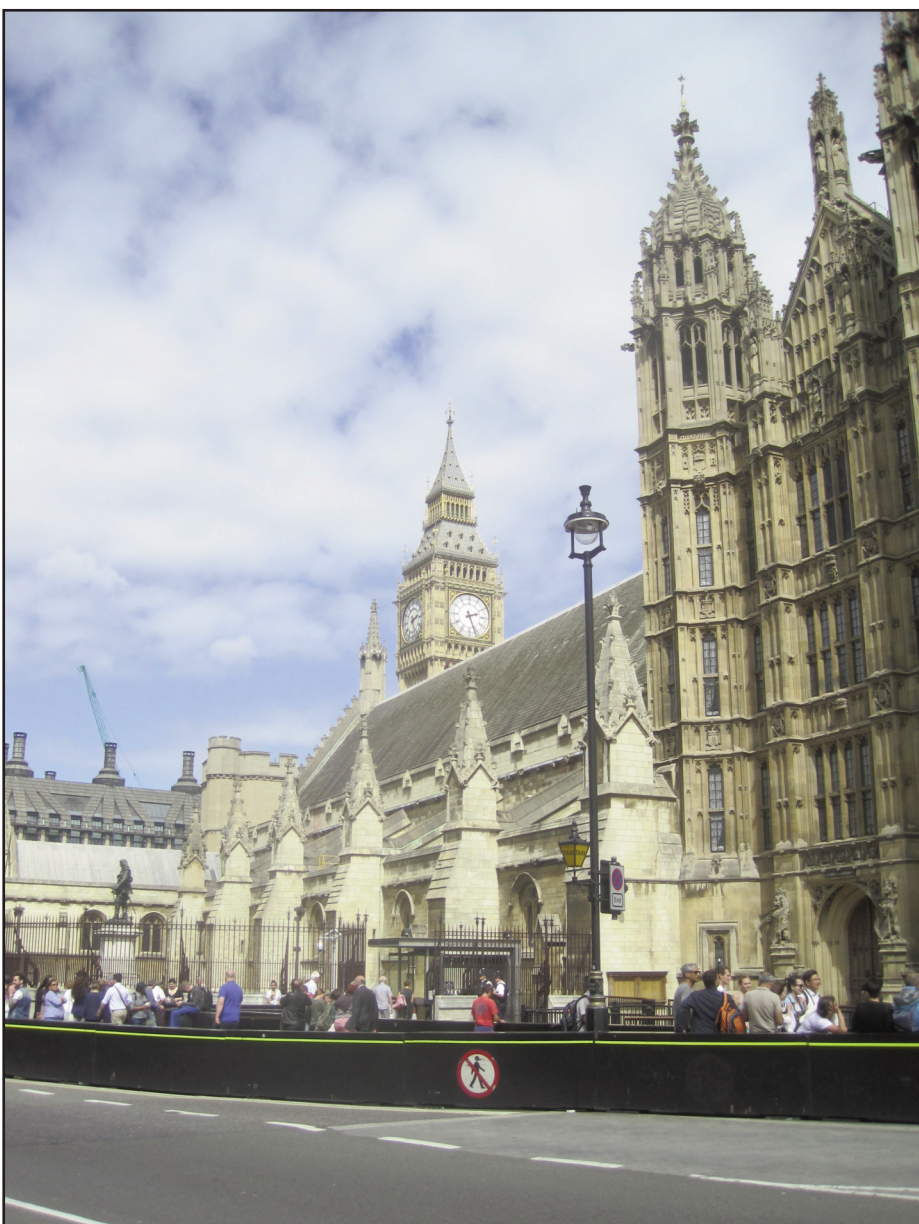
**Figure 2.** The Palace of Westminster showing pale-coloured Clipsham Stone from recent repairs, contrasting with Clipsham Stone from previous repairs and Anston Stone.

Original selection of stone was not always good, even in the case of some prestigious buildings. An example is the Palace of Westminster (often referred to as the Houses of Parliament) in London, UK, which has World Heritage status (Fig. 2). The original medieval buildings were largely destroyed by fire in 1837. A replacement was commissioned in the then popular Gothic Revival style and was completed in stages between 1847 and 1852 ([www.parliament.uk/about/living-heritage/building/palace/architecture/palacestructure/the-stonework](http://www.parliament.uk/about/living-heritage/building/palace/architecture/palacestructure/the-stonework)). The stone selected for the new building was *Anston Stone* (Cadeby Formation, late Permian), a dolomitic limestone from Nottinghamshire (Anonymous 2012a). A variety called 'Mansfield White' was selected because it could be easily carved and was available at a favourable price. However, it performed badly from the outset because of rapid weathering exacerbated by acidic rainfall and fog resulting from the predominant use of coal as a fuel in London until the mid-20<sup>th</sup> century and, subsequently, pollutants mainly from road traffic. By the 1930s it was necessary to begin replacing the Anston Stone with Clipsham Stone (Middle Jurassic), a pale ooidal to bioclastic limestone similar in colour to Mansfield White but with different physical properties (Anonymous 2012b). After suffering bomb damage in the 1940s that program was completed in the 1950s and thus most of the present façade is in Clipsham Stone. But, by the 1960s, damage was again evident, leading to further works from 1984 to 1991. However, in 2012 it was again necessary to begin extensive repair work, which is likely to last for many years but at a cost of several billion £GB. Although the Anston Stone had proved to be inadequate, significant amounts still remain in the structure. But as the Clipsham Stone has also deteriorated badly, this raises the issue of whether newly quarried Clipsham Stone should be used for partial compatibility, or whether a more durable stone might replace it even though that could affect the future performance of older parts of the structure. This illustrates the need to select good stone at the outset, taking into account the environmental conditions that it will be exposed to and the dilemma that can face the repairer after an alternative replacement stone has been used.

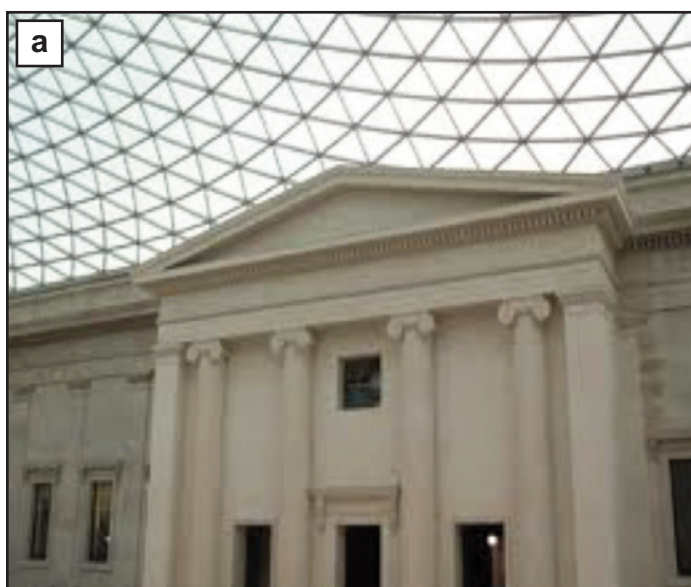
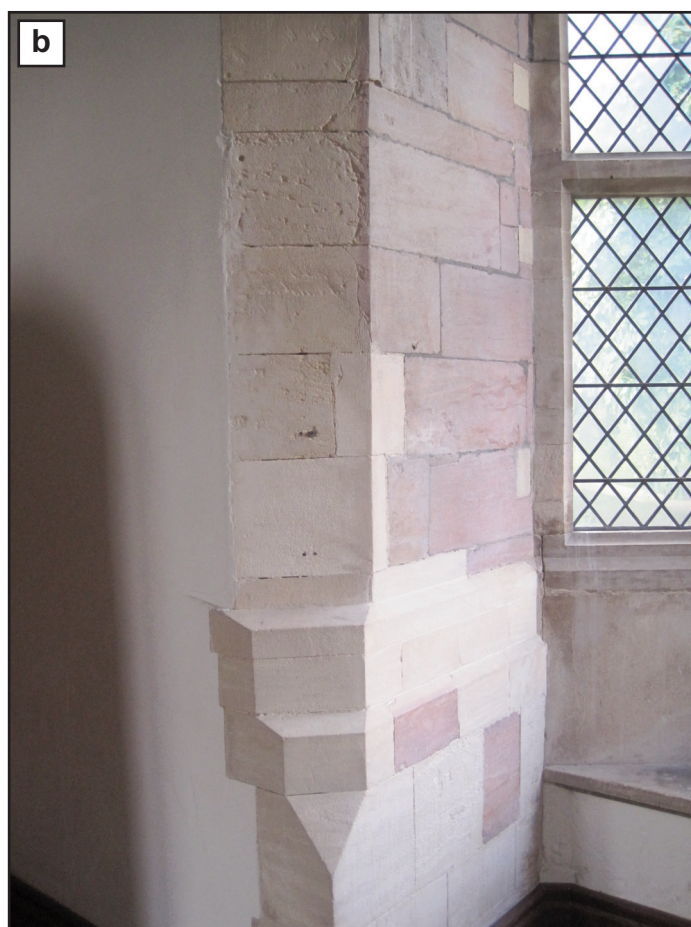
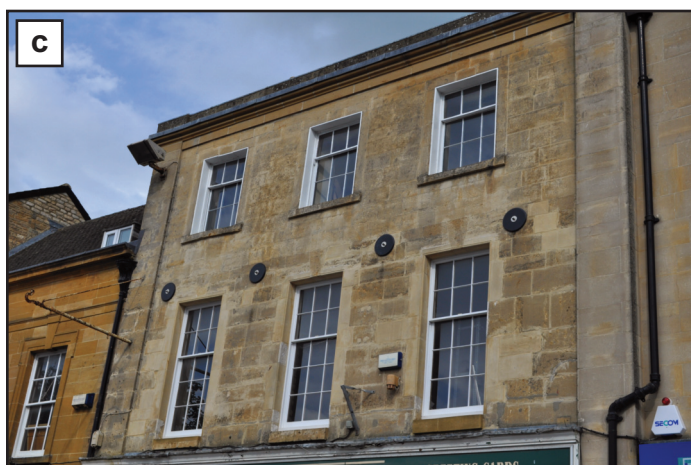
**Figure 4.** Examples of controversial or poor practices of stone usage. a) Queen Elizabeth II Courtyard, British Museum, London; b) contrasting replacement of stone in the interior of the Lincoln Cathedral, and c) replacement with stone of a different colour disrupting the original colour pattern in the exterior of the cathedral, Chipping Norton, Oxfordshire.

The British Museum was founded in 1753 as the world's first national public museum. The present building on the site was constructed in stages between the 1820s and 1850s using granite for the base courses and *Portland Stone* (Tithonian, Upper Jurassic) for the main body of the structure ([http://www.britishmuseum.org/about\\_us/the\\_museums\\_story](http://www.britishmuseum.org/about_us/the_museums_story)). In 2000, an internal courtyard was roofed over to form the Queen Elizabeth II Great Court, expanding visitor space by some 40%. The original Ionic portico of the courtyard had been demolished in the late 19<sup>th</sup> century. It was to be replaced (Fig. 4a) and the specification stated that the work should use 'stone from Portland.' In the event, Middle Jurassic stone imported from France (via Portland) was used, causing a major controversy in which some people considered that the stone was inappropriate while others praised the major architectural achievement ([www.theguardian.com/the\\_observor/2000/nov/12/2](http://www.theguardian.com/the_observor/2000/nov/12/2)). The colour and texture do not match and, since this part of the building is sheltered from weathering, the contrast is unlikely to decrease over time. This illustrates the importance of precise specification of stone but also raises the question of whether some changes should be allowed for architectural reasons.

rent repair and maintenance work employs appropriate stone but the building shows evidence of 19<sup>th</sup> and early 20<sup>th</sup> century interior work that is aesthetically unpleasing. Parts of the interior walling were originally built with red sandstone (Triassic) but some repairs were made with white limestone (Lincolnshire Limestone; Bajocian, Middle Jurassic) (Ashton 1980), of a type used extensively elsewhere in the cathedral. This resulted in an irregular patchwork of contrasting colours (Fig. 4b) that some consider undesirable.

Many buildings in the town of Chipping Norton date from the 18<sup>th</sup> century and were constructed mainly with *Hornton Stone* (bioclastic ferruginous limestone; Pleinsbachian–Toarcian, Lower Jurassic). This stone is susceptible to spalling. Chipping Norton Limestone (oolitic limestone; Bajocian, Middle Jurassic) (Horton and Edmonds 1987; Radley 2003, 2009) was used for detailing around windows in the structure illustrated in Figure 4c, providing a pleasing contrast. That colour pattern was disrupted by later repairs that used Middle Jurassic limestone in place of some of the darker Hornton Stone (Fig. 4c); the result is not likely to become visually compatible even after a period of weathering.

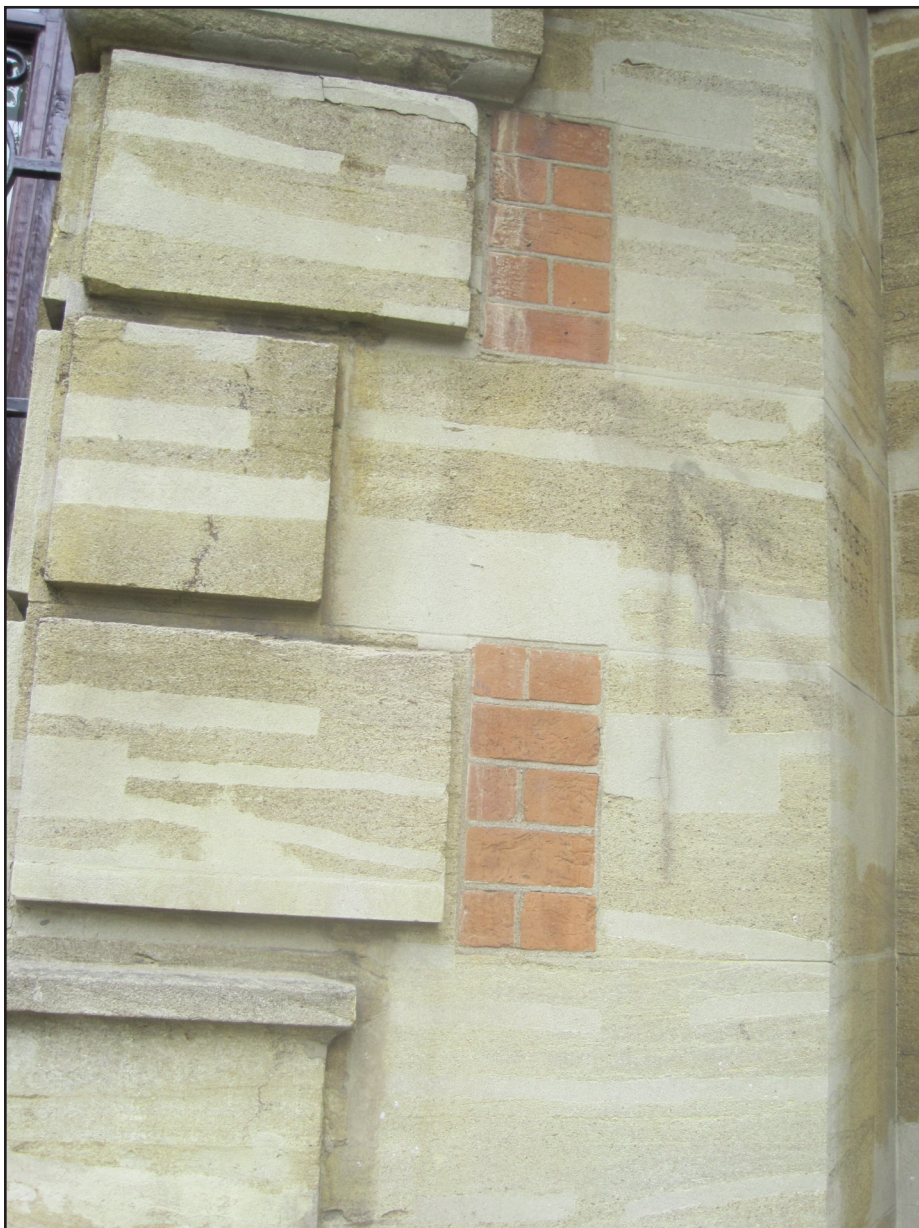
**Figure 7.** Part of the façade of a bank in Hampstead, London, showing inappropriate use of cement and brick in repairs to Douling Stone.

observed at the front of a bank in Hampstead, London. The façade was constructed with *Douling Stone* from Avon (crinoidal biosparite; Bajocian, Middle Jurassic), which contains numerous large *Thalassinoides* burrows (Richardson 1915). The infilled burrows are more porous than the body of the rock, and weather more quickly. During ‘repair,’ the hollows associated with these burrows were simply cemented over but some red bricks were also used to replace seriously weathered stone blocks, producing a poor visual result (Fig. 7). While this is a minor building, these repairs detract from the late 19<sup>th</sup> century terrace of which it is a part.
